Marketing Research Report No. 485

TRANSPORTATION OF HANGING BEEF BY REFRIGERATED RAIL CARS AND 'PIGGYBACK' TRAILERS

By H. D. Johnson, R. F. Guilfooy, and R. W. Penney,
Transportation and Facilities Research Division,
Agricultural Marketing Service

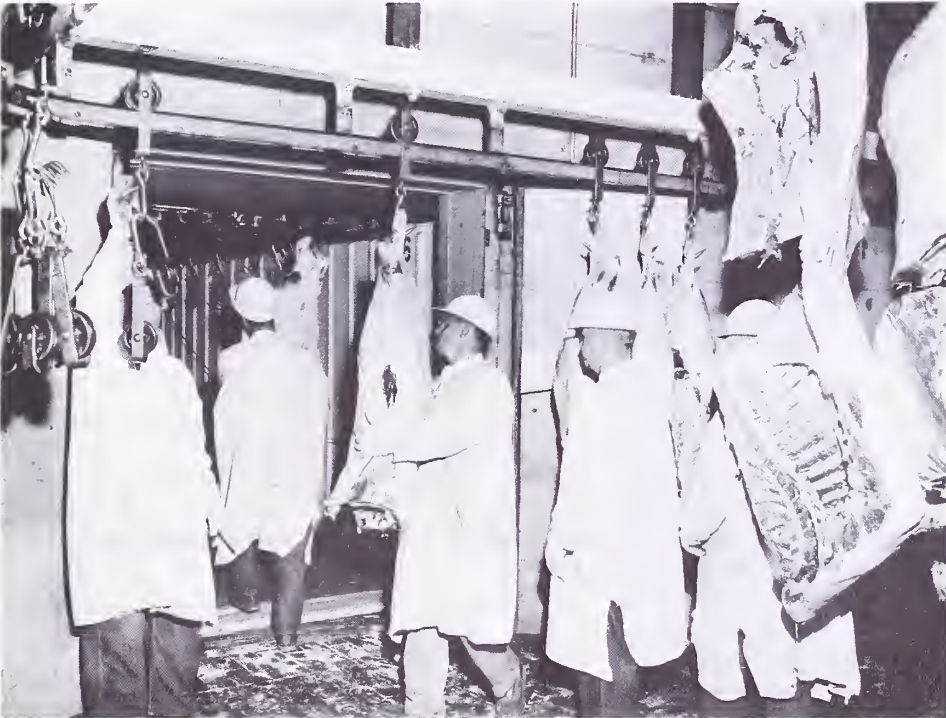
BN-13574x

Figure 8.--Loading beef from packing plant into one of the trailers.

The six loads of beef were taken from the same chilling room so that the beef temperatures at loading would be approximately the same for all trailers and cars. Figure 8 shows quarters of beef being removed from an overhead conveyor and loaded into one of the trailers; figure 9 shows a partially loaded car.

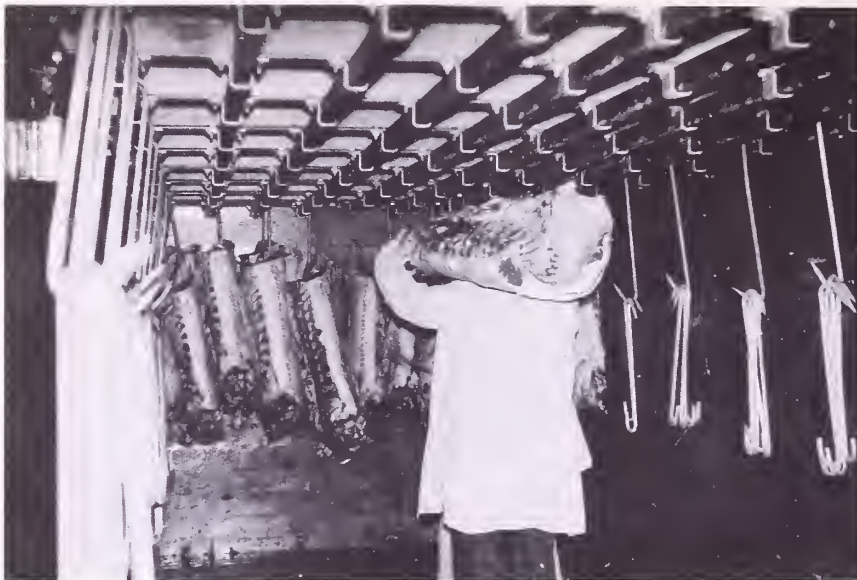
BN-13576x

Figure 9.--Loading one of the cars.

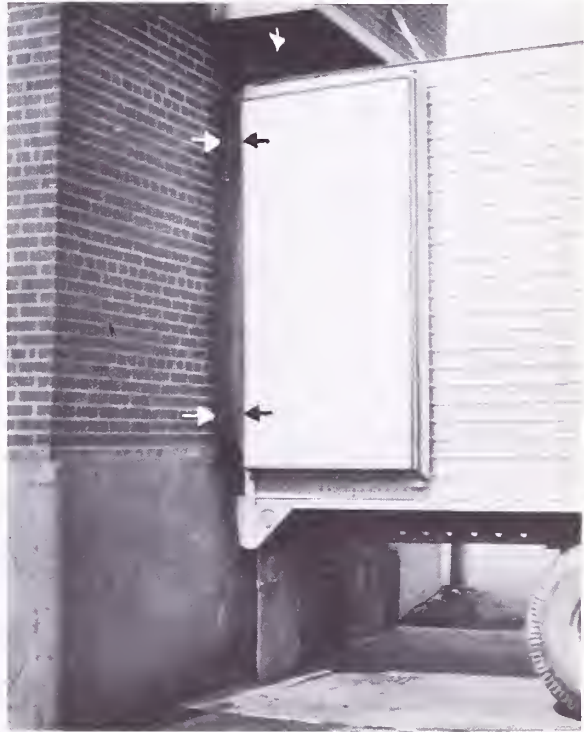
BN-13580x

Figure 12.--Trailer backed against foam rubber (indicated by arrows) at loading door.

Figure 11 shows foam rubber strips around the sides and top of three of the loading doors at the packing plant where the trailers were loaded. These strips were approximately 12 by 12 inches in cross section. Figure 12 shows a trailer backed against this foam rubber, thereby preventing the warm outside air from entering the trailer. The meat was moved directly from the refrigerated plant into the trailer. The interior of the trailer stays cooler when this arrangement is used than when the meat is moved across open loading docks into the trailer.
